UNDERWATER BRIDGE INSPECTION REPORT

STRUCTURE NO. 57521

RED LAKE RIVER

DISTRICT 2 - PENNINGTON COUNTY

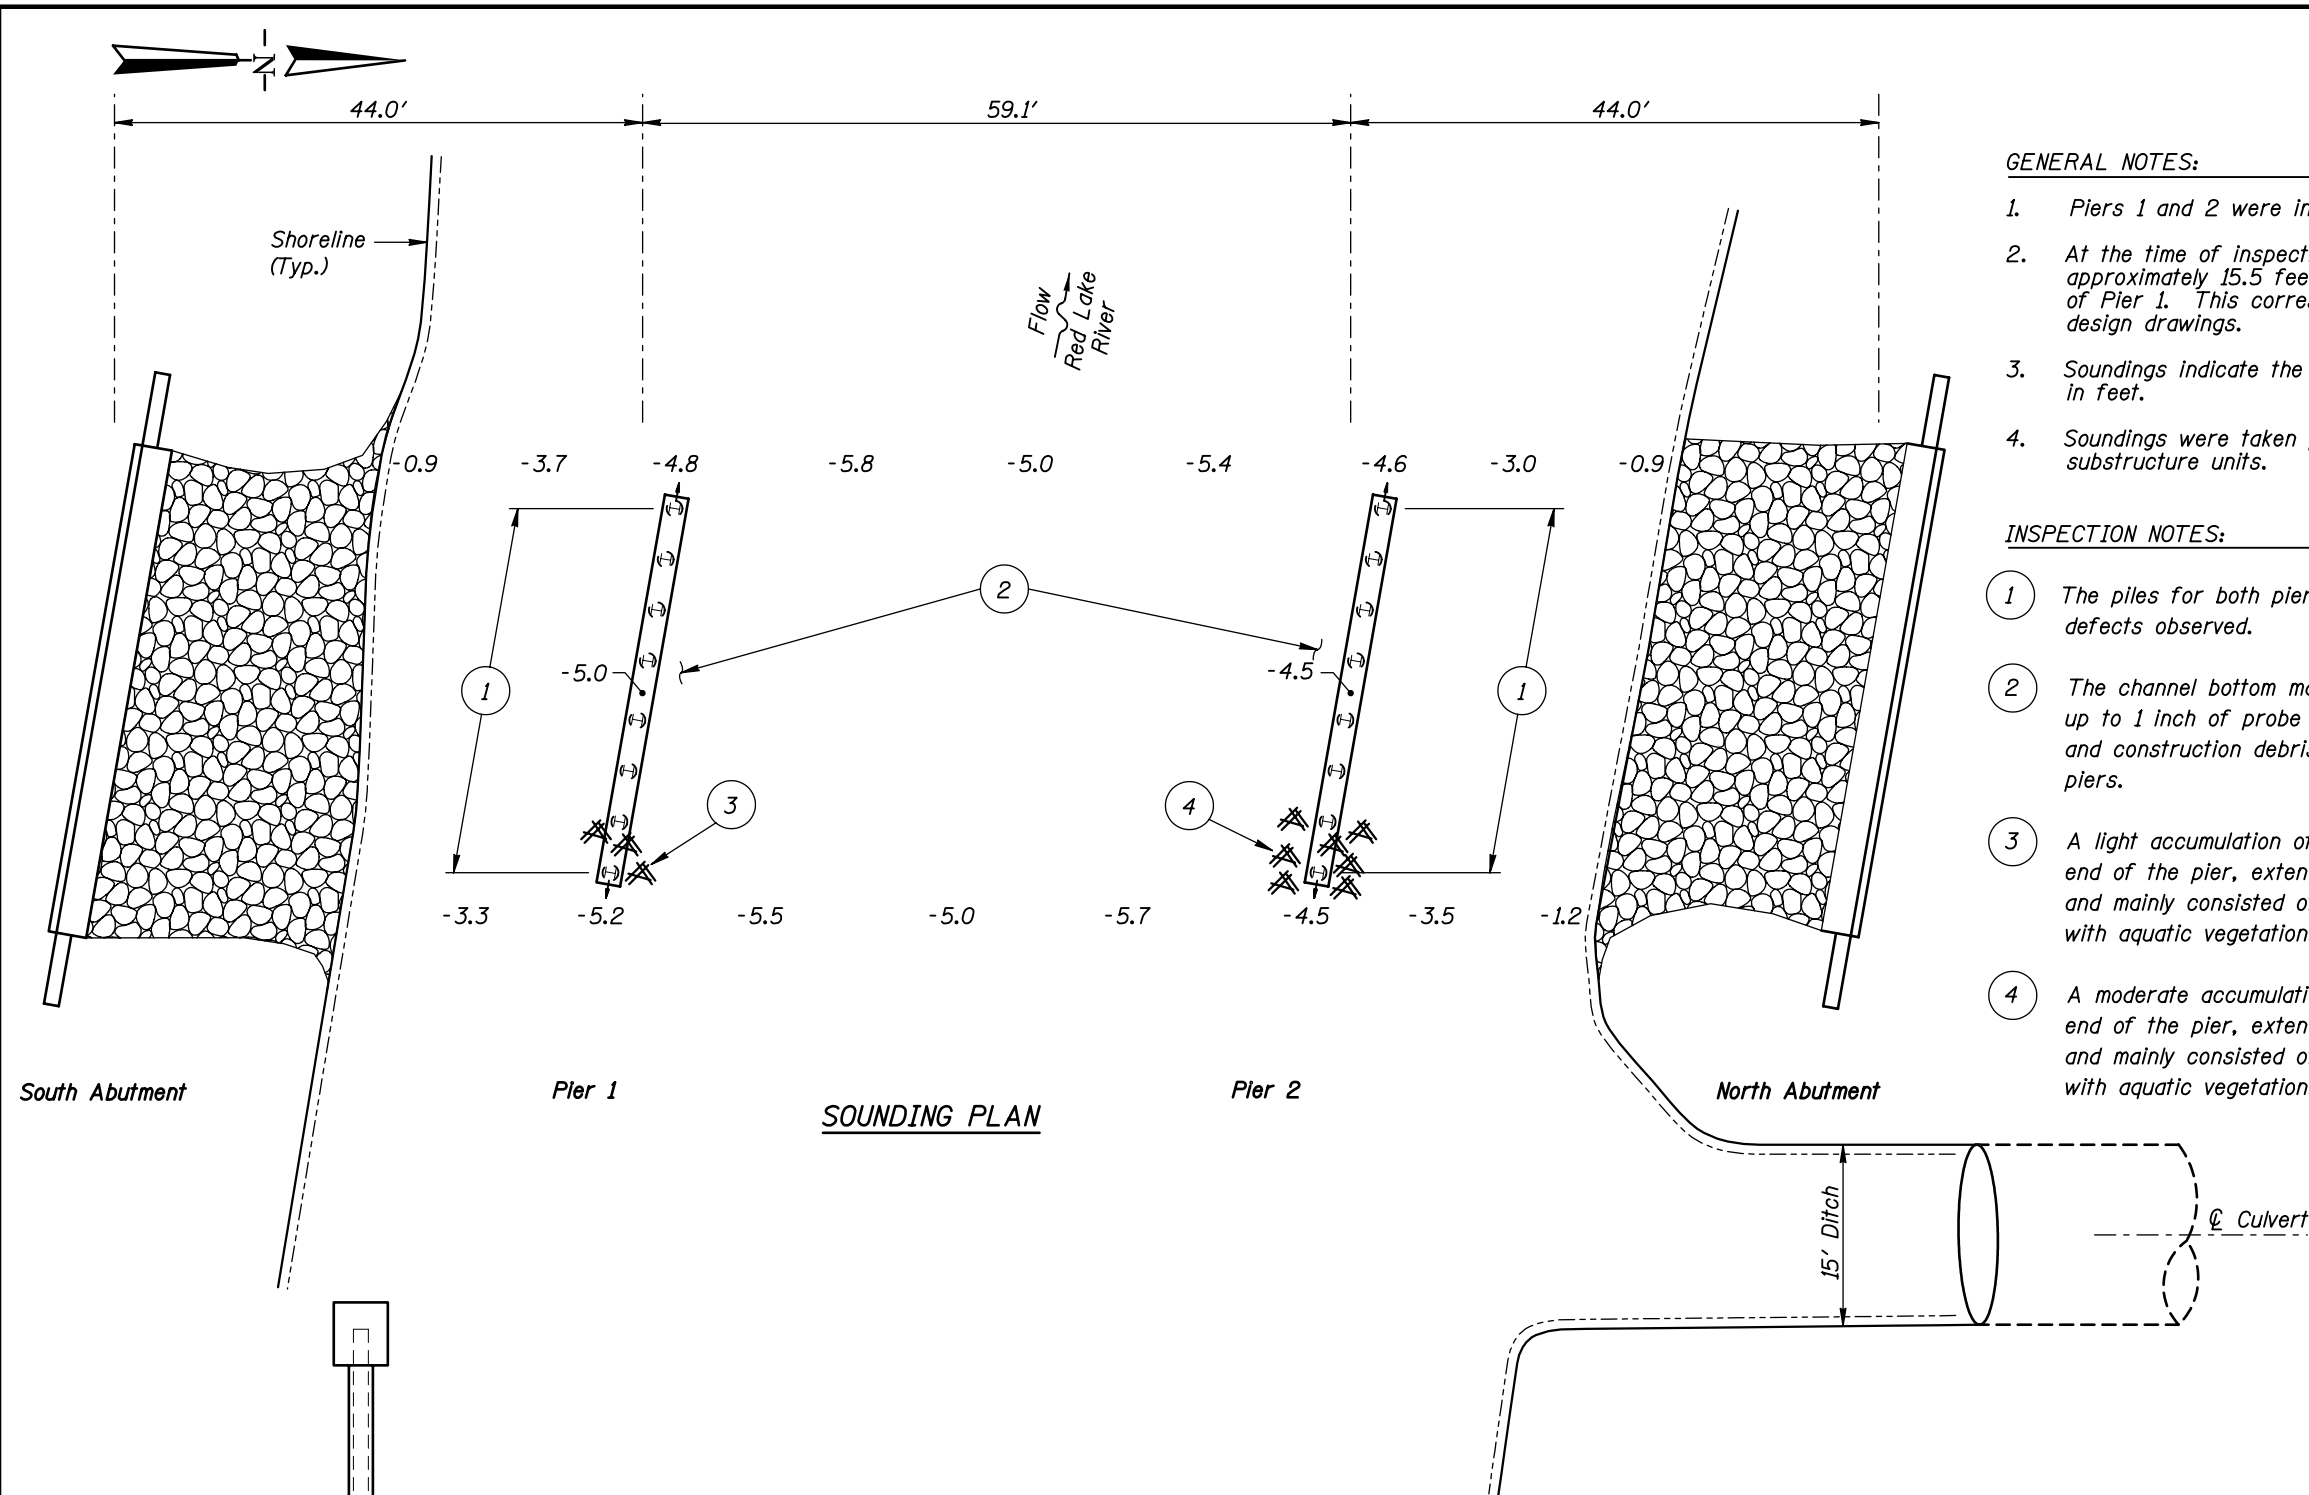
INSPECTION AND SOUNDING PLAN

1. The piles for both piers were in good condition with no significant defects observed.
2. The channel bottom material consisted of firm sand and gravel with up to 1 inch of probe rod penetration. There was also scattered riprap and construction debris observed around the upstream piles for both piers.
3. A light accumulation of timber debris was observed at the upstream end of the pier, extended from the waterline to the channel bottom, and mainly consisted of 3 inch diameter or smaller branches along with aquatic vegetation.
4. A moderate accumulation of timber debris was observed at the upstream end of the pier, extended from the waterline to the channel bottom, and mainly consisted of 3 inch diameter or smaller branches along with aquatic vegetation.

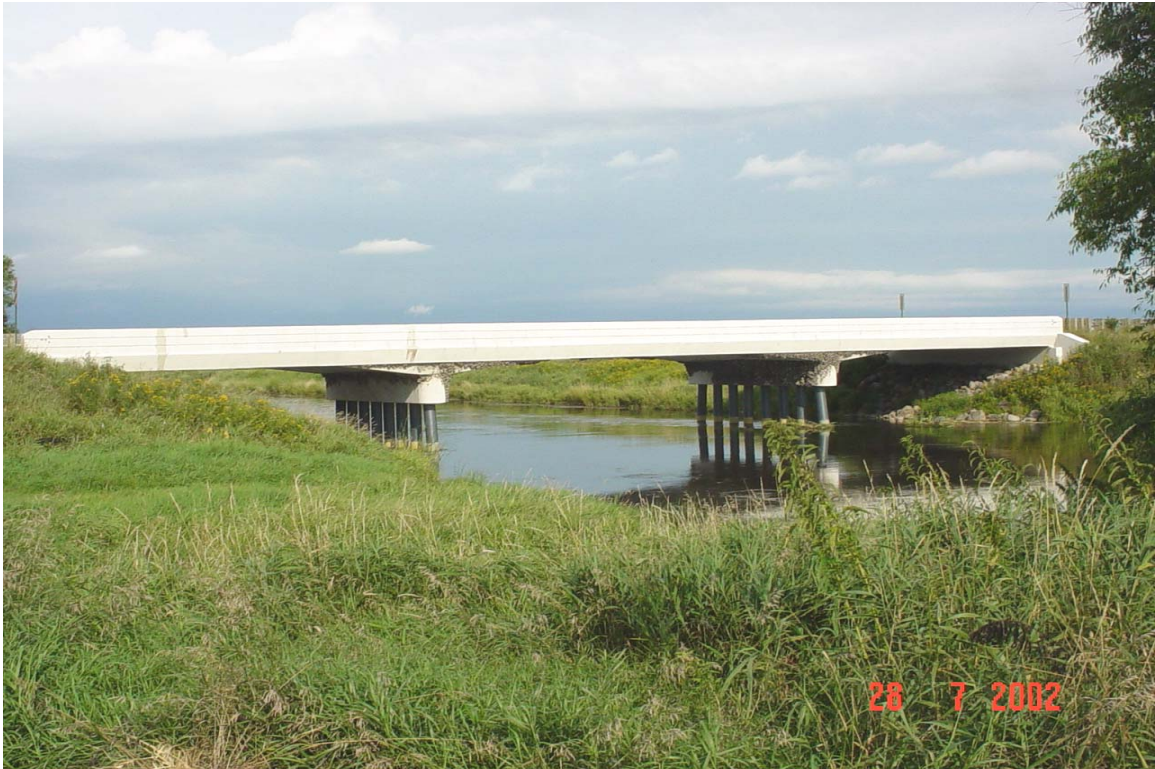
Photograph 1. Overall View of the Structure, Looking Northwest.

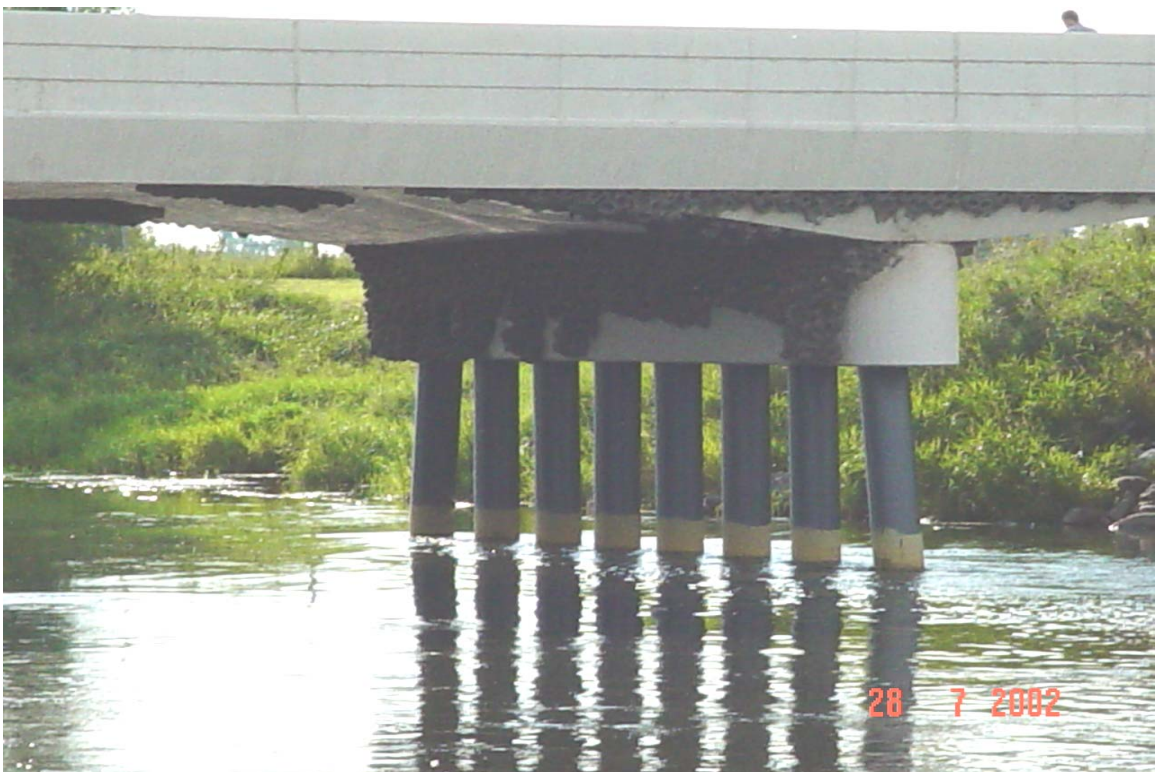
- (A) Around the upstream piles of Piers 1 and 2, there were light and moderate accumulations of timber debris, respectively. Each accumulation was primarily located at the upstream two piles of the pier, extended from the waterline to the channel bottom, and mainly consisted of 3 inch diameter or smaller timber debris along with aquatic vegetation.

Photograph 2. View of Pier 1, Looking Southeast.

- (A) Monitor the timber debris accumulation at both piers, and if found to be increasing in the future, removal operations may become warranted.

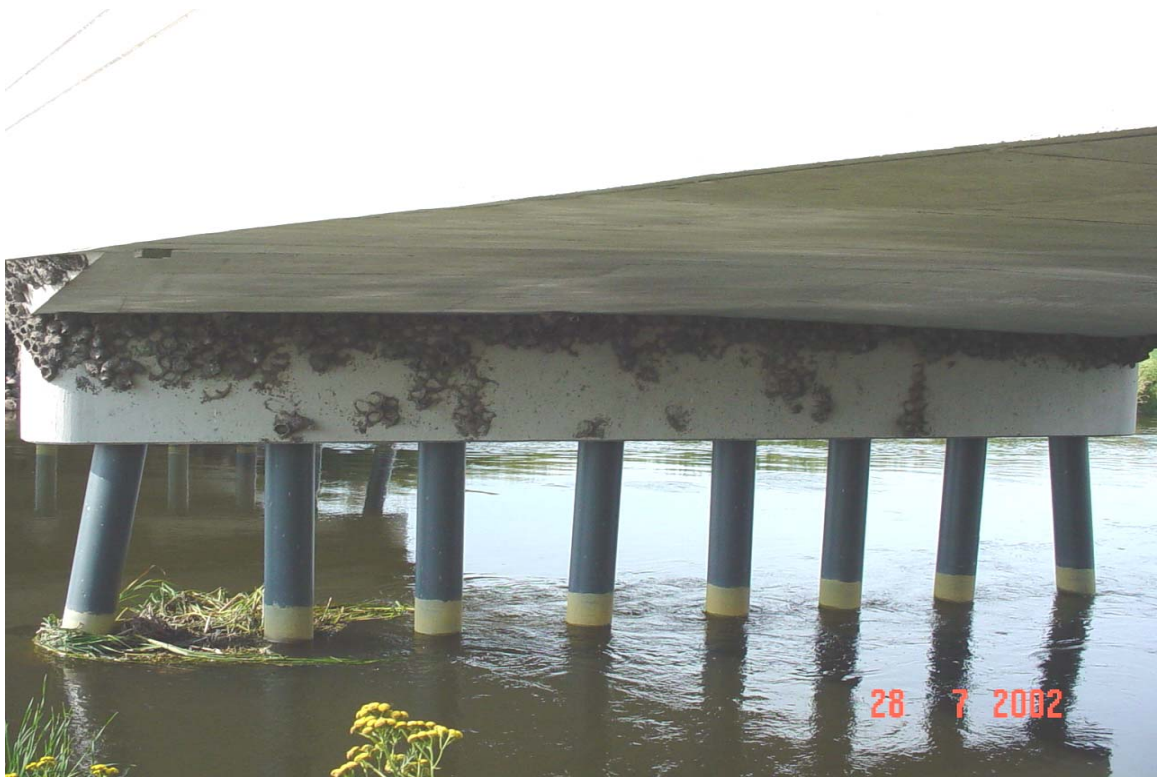
Photograph 3. View of Pier 2, Looking Southwest. Note the Accumulation of Timber Debris and Aquatic Vegetation at the Upstream Nose of the Pier.
